# Radiation Effects Predicted, Observed, and Compared for Spacecraft Systems

Presented at the  
Space Parts Working Group  
Hardness Assurance Committee

September 10, 2002

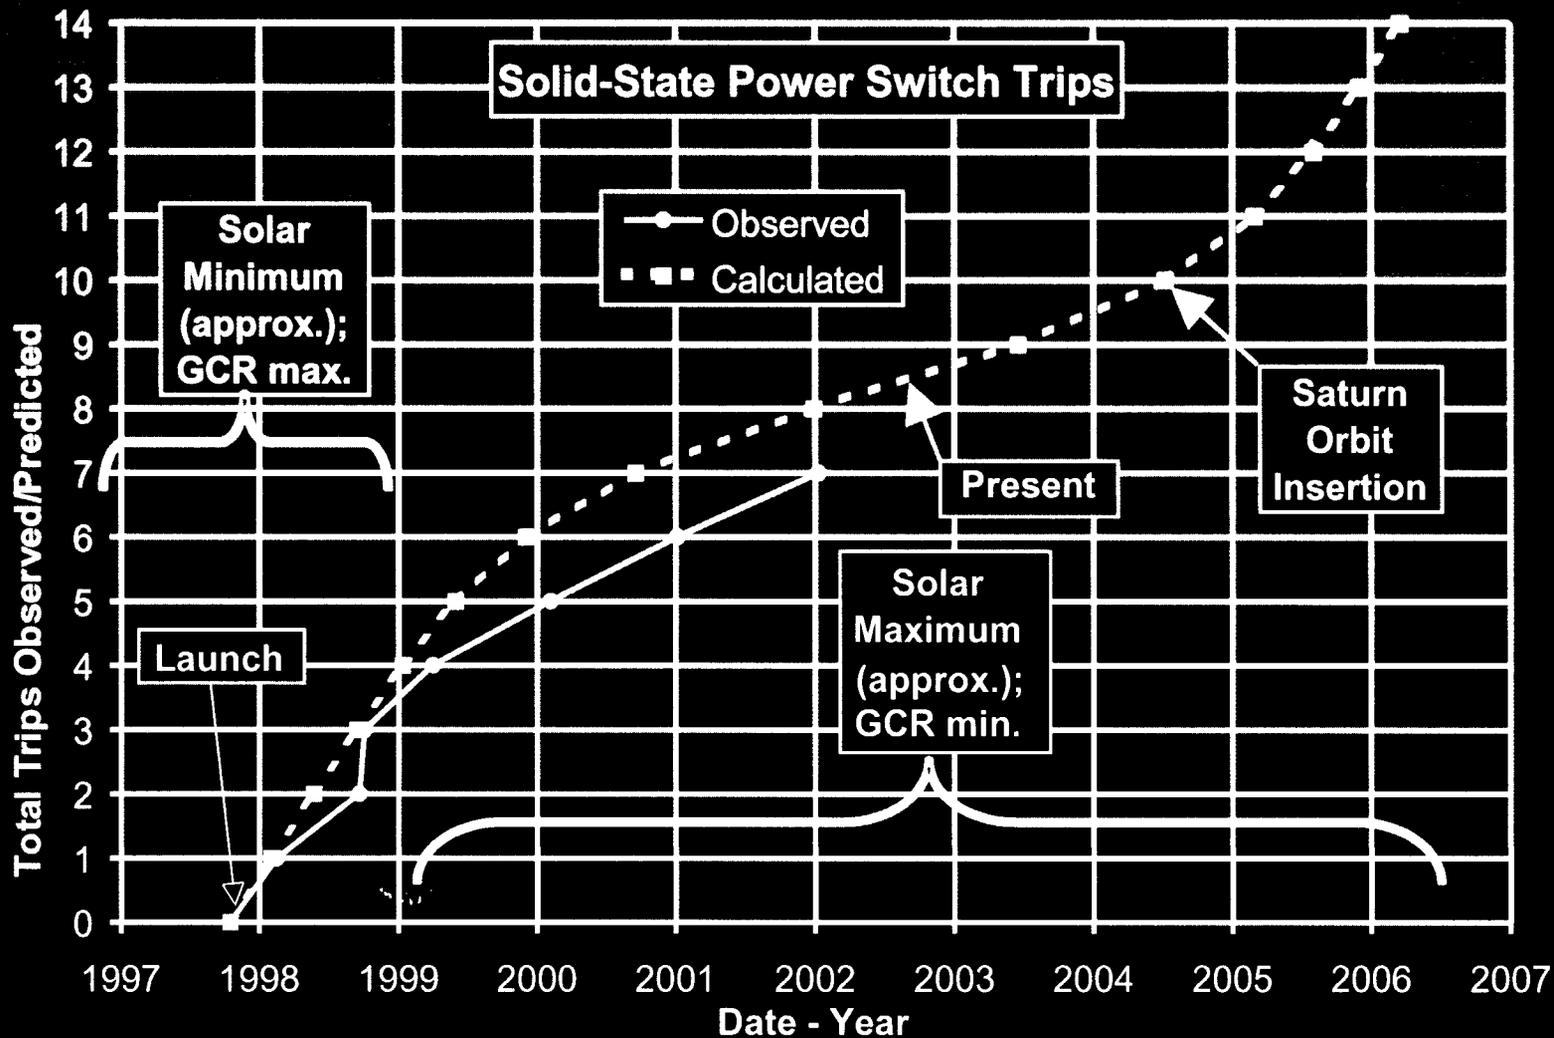
# Comparison of Cassini SSPS Trips (observed vs. calculated)

- **Seven trips in almost 5 years (206 switches)**
- **Subsequently investigated**
  - **Caused by single-event transients (SETs) in LM139 comparators**
  - **Trips always occur in same mode (Off-to-trip)**
  - **Trip rate appears to change with time**
- **Comparators tested at Brookhaven**
  - **Results consistent with earlier work by Aerospace**
- **Trip rates earlier calculated for maximum & minimum galactic cosmic ray (GCR) fluxes**
  - **Figure compares observed trips versus number calculated, based on expected modulation of GCR flux**
  - **Calculation correlates well with observed trip rates**
  - **Suggests trip rate will remain at low level for remainder of voyage to Saturn (arrival expected July 4, 2004)**

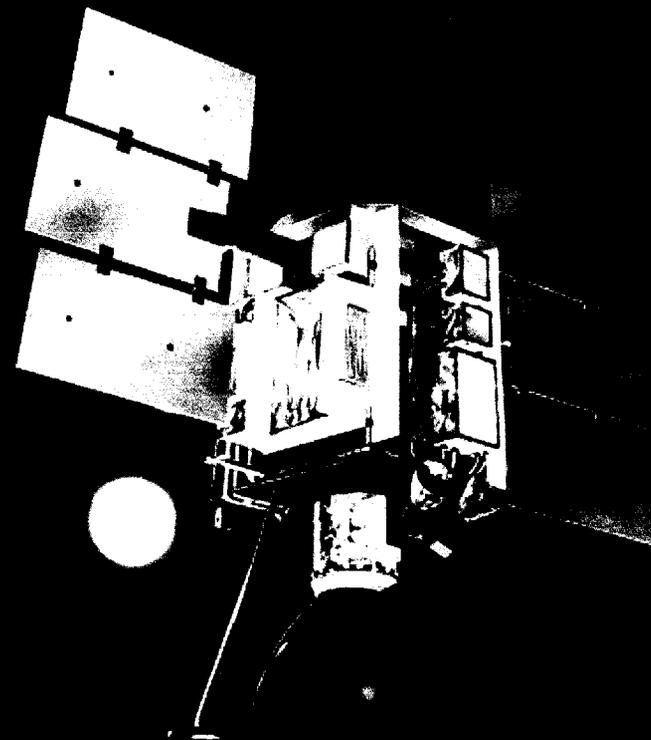
- **Several anomalies noted by Ball Aerospace**
  - **SEU in computer 3 days after launch**
    - **Correctable error in unused memory**
    - **No mission impact**
    - **Other miscellaneous SEUs noted, corrected by EDAC**
  - **SEU rate in Solid-State Recorder lower than expected**
    - **$1.5 \times 10^{-7}$  errors/bit-day (predicted  $1.2 \times 10^{-6}$ )**
    - **All corrected by EDAC in SSR**
  - **Upsets in 1553 bus**
    - **Error detection normally prompts data retransmission**
    - **Therefore, no mission impact**
  - **Star-tracker anomalies – noisy data, background high readings**
    - **Recovers automatically, no mission impact**
  - **GPS receiver failure (Motorola Viceroy model)**
    - **Consistent with latchup**
    - **Switched to redundant unit, no mission impact**

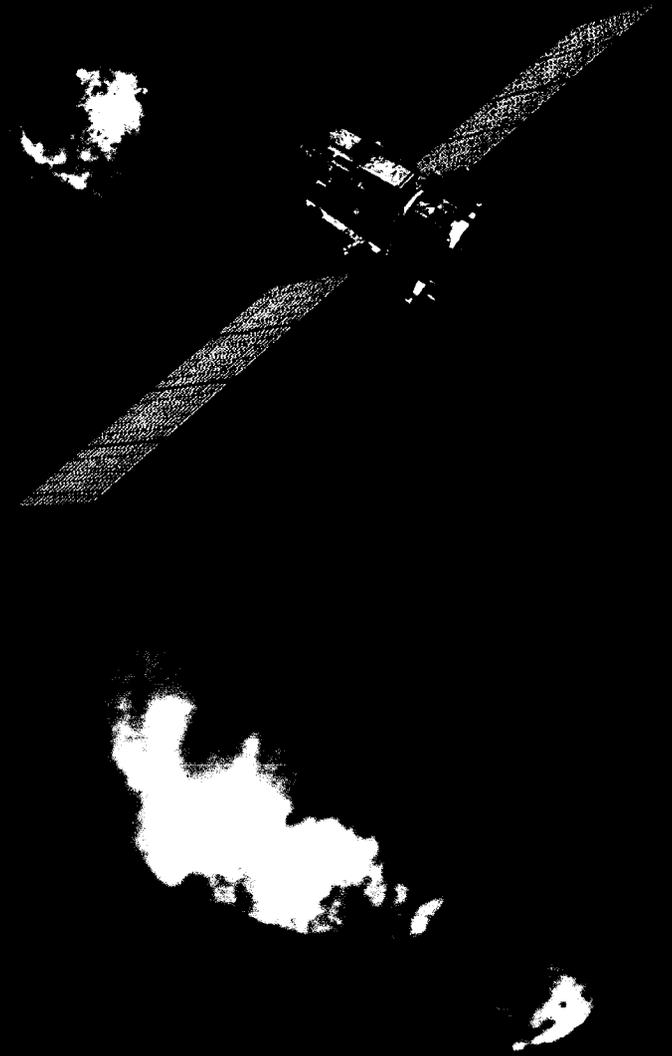
- **Technology demonstration spacecraft**
- **SEU in Gimbal Drive Electronics FPGA resulted in loss of power from 1 solar panel – caused safe-hold**
- **Commercial stellar reference unit (SRU) failed during extended mission**
  - Believed due to latchup
  - Power-cycled twice in attempt to revive, but unsuccessful
  - SRU had intermittent problems starting soon after launch
  - All were investigated, but no resolution
  - Failure consistent with latchup, but other failure modes could not be ruled out
- **Completed extended mission to Comet Borrelly by ingenious use of other sensors (on-board camera/spectrometer) to determine attitude** →
