Comparison of X-ray Inspection Systems for BGA/CCGA Quality Assurance and Crack Detection

R. Ghaffarian , D. Mih
Jet Propulsion Laboratory, California Institute of Technology , Pasadena, CA
Reza.Ghaffrian@JPL.NASA.Gov, (818) 354-2059

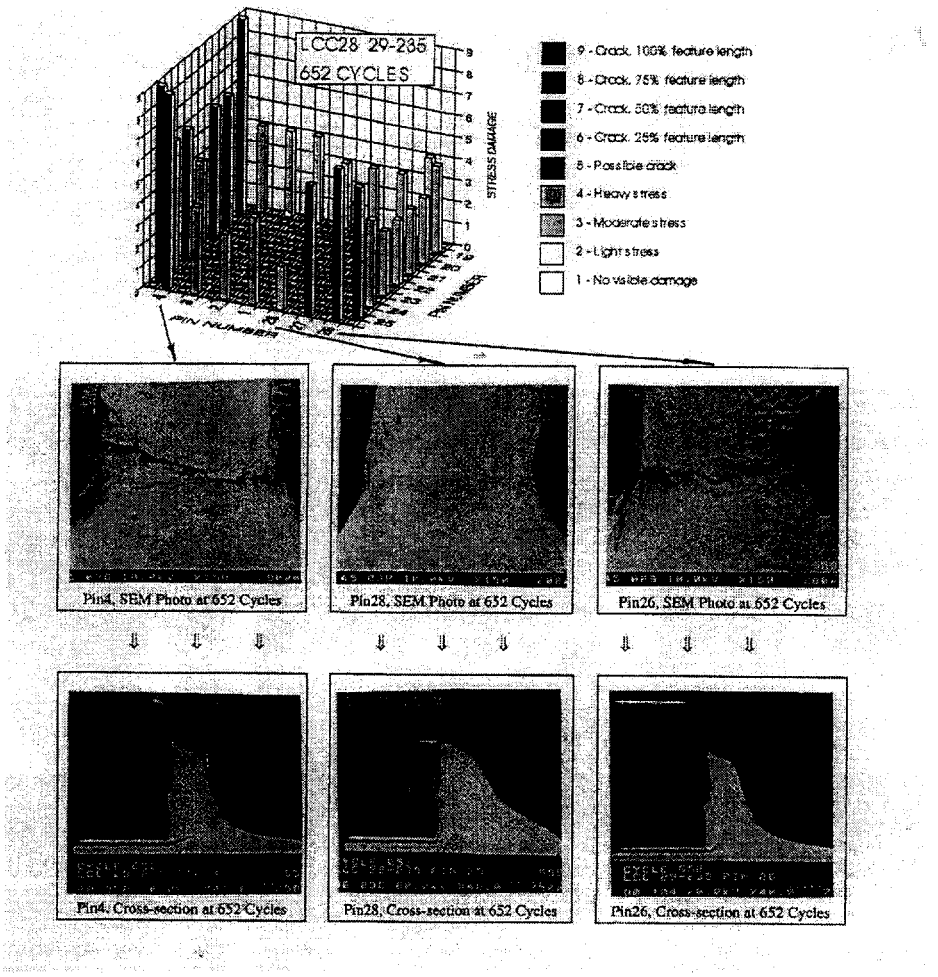
For leaded and leadless package solder joints, the author has performed visual inspection at low and high magnifications to correlate damage level results to those revealed by cross-sectioning [7-8]. Numerous leaded and leadless packages were subjected to thermal cycle, removed at intervals, inspected visually and by scanning electron microscopy (SEM), and results were correlated to cross-sectioning images. An example of such correlation for a ceramic leadless package with 28 I/Os is shown in Figure 1. Assemblies were subjected to –55 to 100°C, 4.2 hours per cycle, and stopped at 652 cycles for cross-section evaluation.

Figure 1 Correlation between visual inspection for damage (crack) progress with thermal cycling and destructive cross-sectional micrographs.

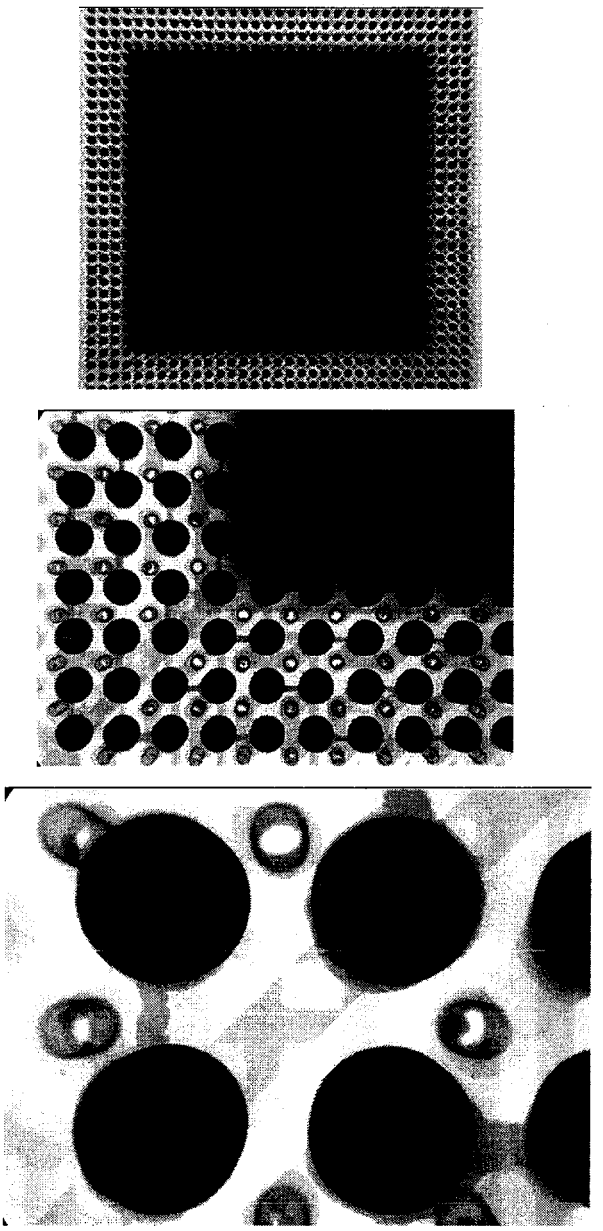
Figure 3 2D X-ray inspection of CCGA assembly after thermal cycles with signs damage/cracking. Damage/cracks are not detectable

CASE 1 — Figure 3 shows X-ray photomicrograph for assembled CCGA after thermal cycle exposure using the 2D X-ray transmission system discussed above for case 1 where parts remained stationary during x-ray exposure. Solder joints could not be detected because of significant x-ray intensity attenuation by CCGA column.

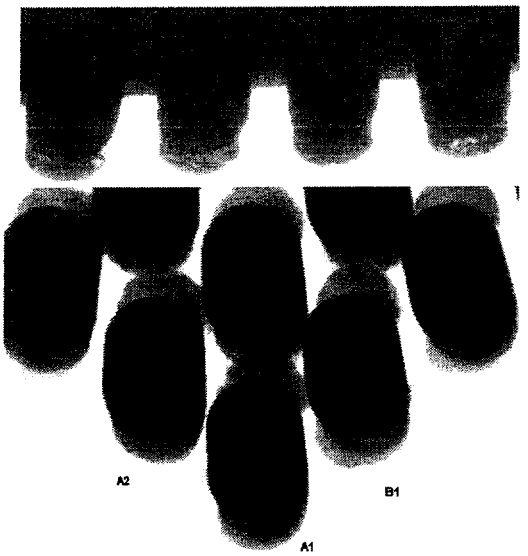
CASE 2 — Figure 4 shows x-ray photomicrographs of assembled CCGA after thermal cycle using the case 2 X-ray system with an oblique view capability. X-ray images from two views are included. CCGA columns having high lead composition (90Pb/10Sn) are much darker than eutectic solder (37Pb/63Sn) used for attachment to the board. Within lighter solder joints at lower section of column, other lighter zig zag lines, possibly caused by cracking, are apparent. Non-smoothness of patterns may be an indication of solder graininess generally occurs as thermal cycle progress due to solder grain growth.

Figure 4 X-ray photmicrographs of CCGA using a 2D X-ray system with oblique detector at two angles

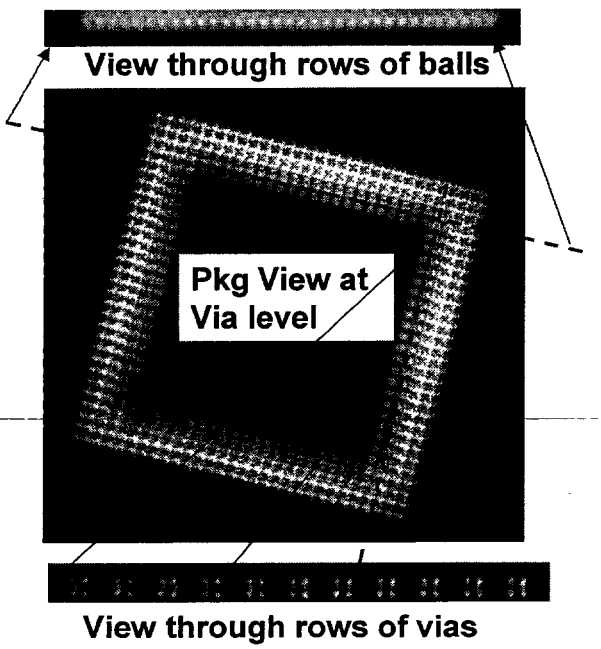
CASE 3 — Figure 5 shows x-ray photomicrographs taken for a cavity down BGA assembly at a specific layer and two 3D cross-sectional images from two locations. Both 2 D image and cross-sectional images provide good information on feature of package and attachment, but lack resolution needed to detect damage/cracks. Further collaborative work is being underway to repeat the test using an x-ray with high resolution capability.

Figure 5 X-ray photmicrographs of SBGA using a 2D/3D volumetric X-ray system
