# Radiation Effects Predicted, Observed, and Compared for Spacecraft Systems

Presented at the  
Space Parts Working Group  
Hardness Assurance Committee

September 10, 2002

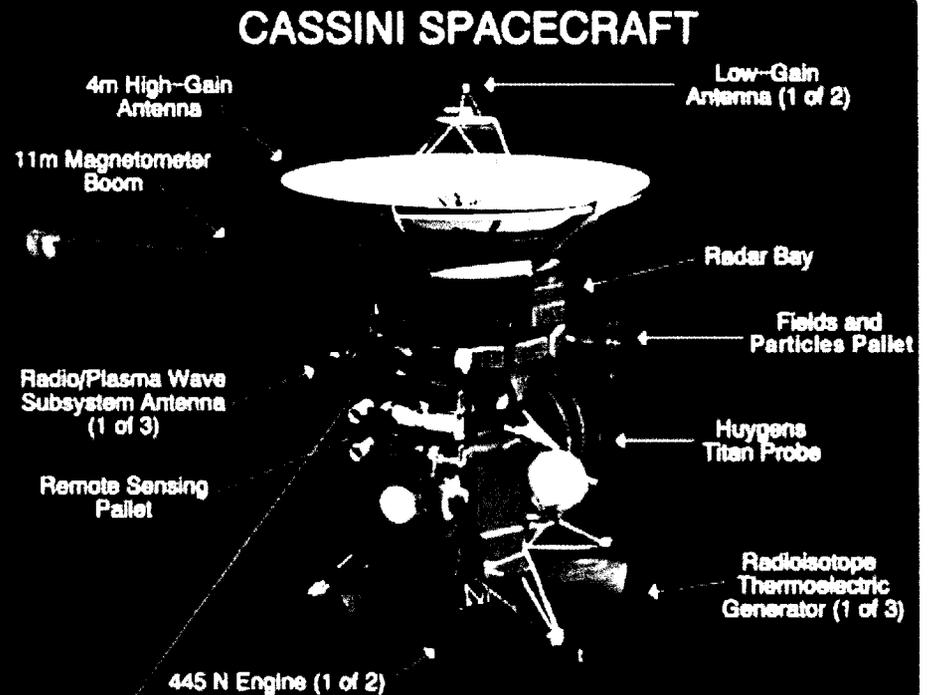
# Cassini

- **Uses Solid-State Recorder (SSR) instead of mechanical tape recorder**
  - Correctable single-bit errors in line with prediction
  - However, double-bit error rate much higher than predicted
- **Cassini also contains numerous Solid-State Power Switches (SSPS)**
  - Switches have tripped 7 times in almost 5 years
  - Not predicted, but subsequently investigated
