## Optomechanical Design of Ten Modular Cameras for the Mars Exploration Rovers

Virginia Ford, Paul Karlmann, Ed Hagerott, Larry Scherr

Jet Propulsion Laboratory, California Institute of Technology

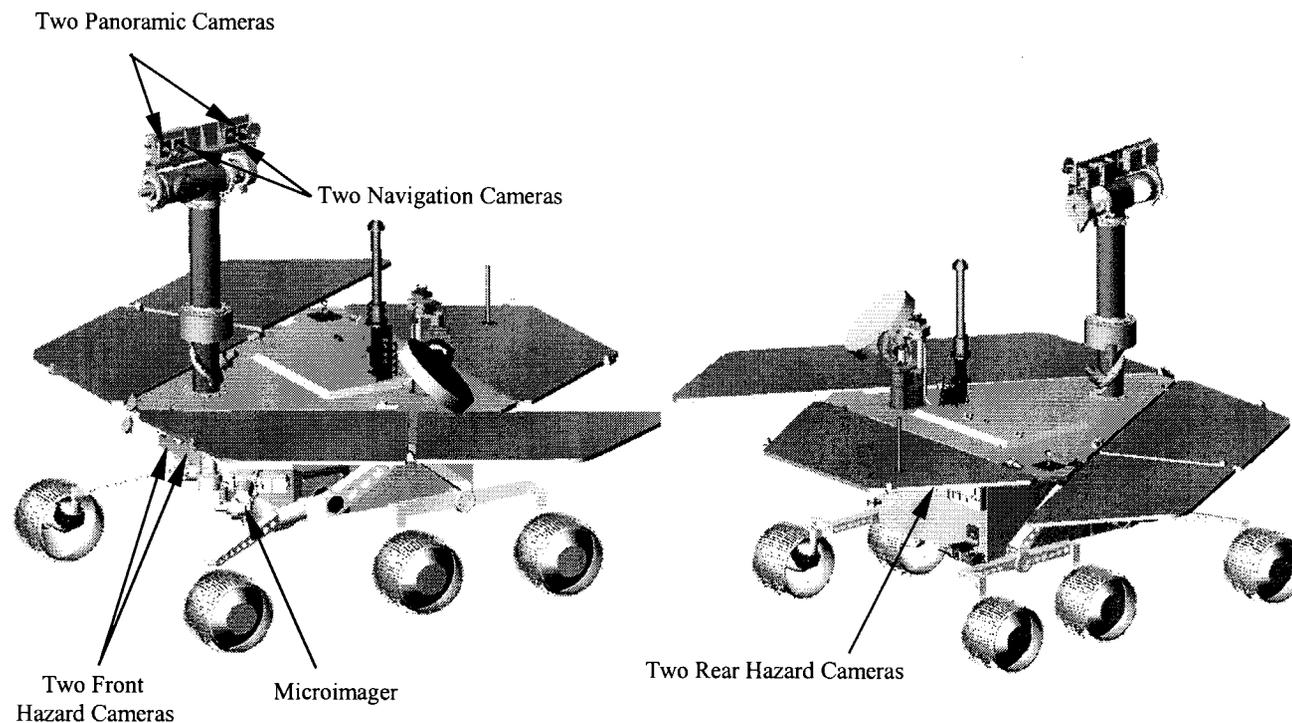
- Ten cameras for each lander and rover:
  - Science cameras: two Panoramic Cameras, one Microimager
  - Engineering cameras: four Hazard Cameras, two Navigation Cameras, on Lander Descent Camera

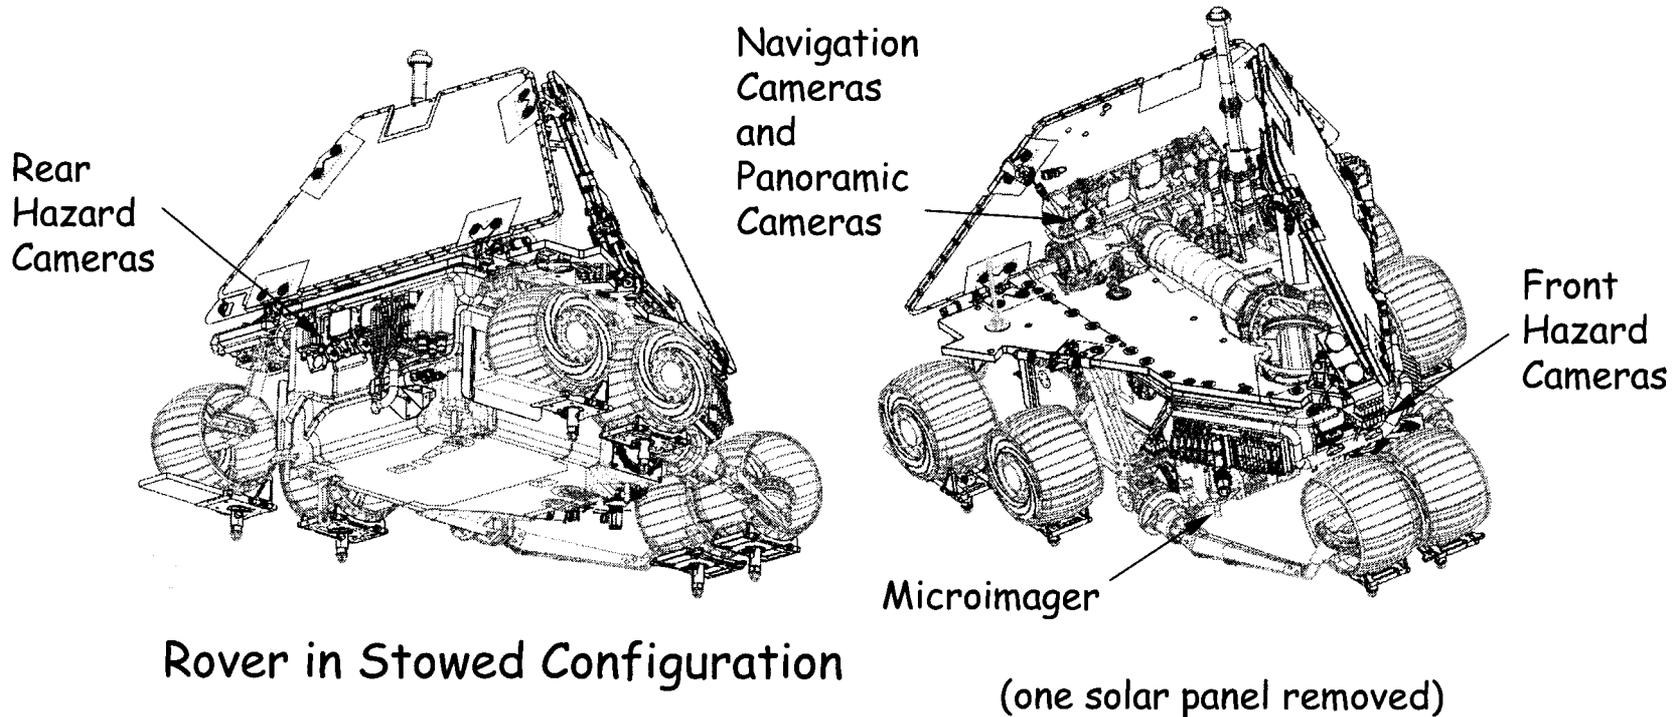
- Design drivers:
  - Volume constraints (and mass)
  - Thermal requirements
  - Versatility requirements

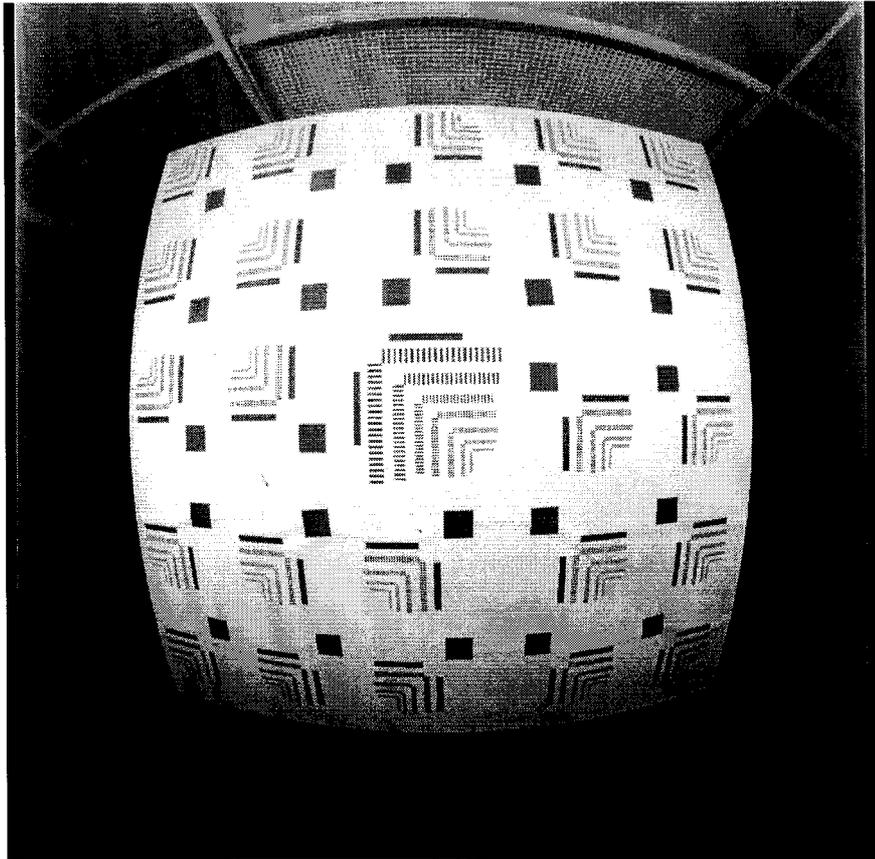
# Hazard Camera Test Images

**1m x 1m Focus Target**

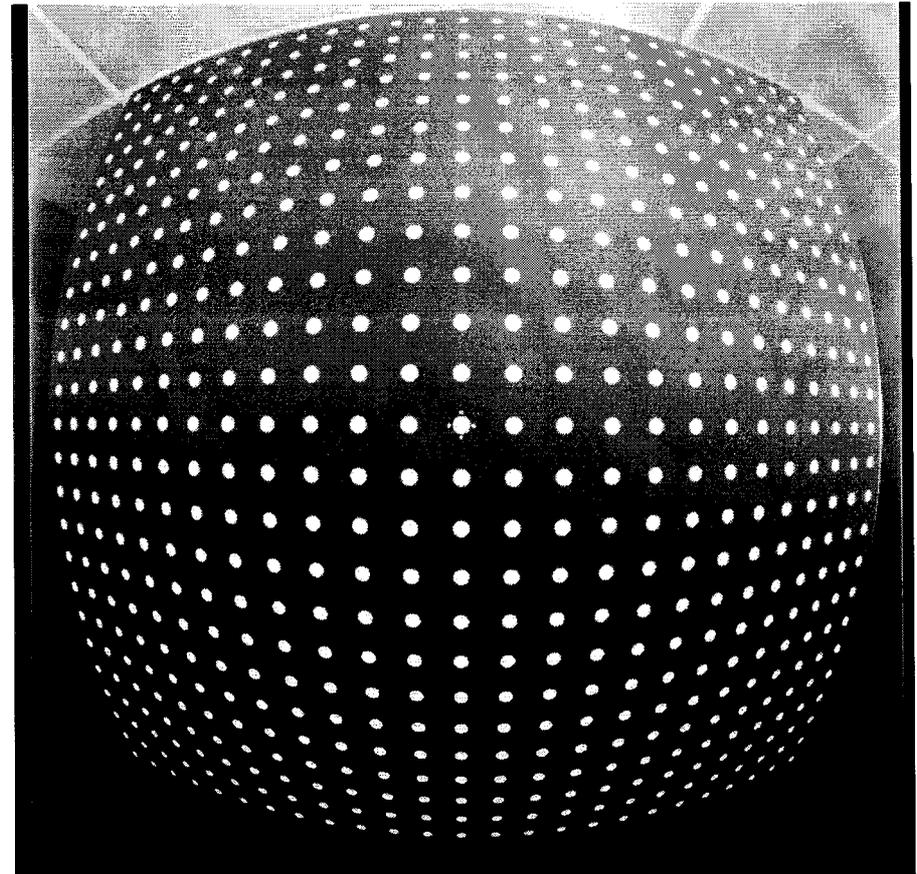
**1m x1m Grid Target**
